## **MVF *Sanu***

## **Mitigation Survey and Timber Recovery**

[Maritime Archaeology Sea Trust](#)

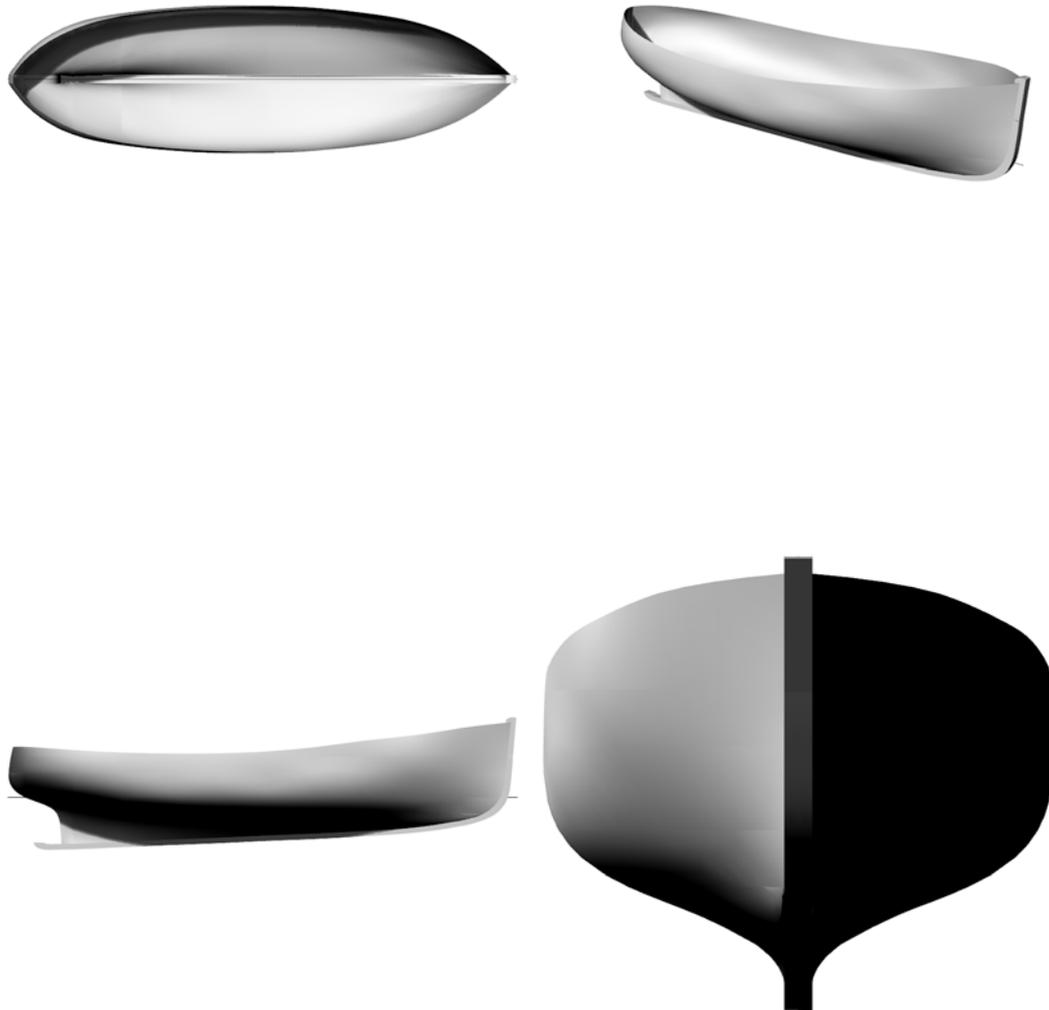
From these line drawings a 3D model was created of how the original sections of the *Sanu* that survived should have looked like. A comparison of the two shows that the hull structure was still rigid and very little damage had occurred as a result of sitting under its own weight.

***Image 2: 3D model of hull from line drawings (courtesy of Tom Cousins)***

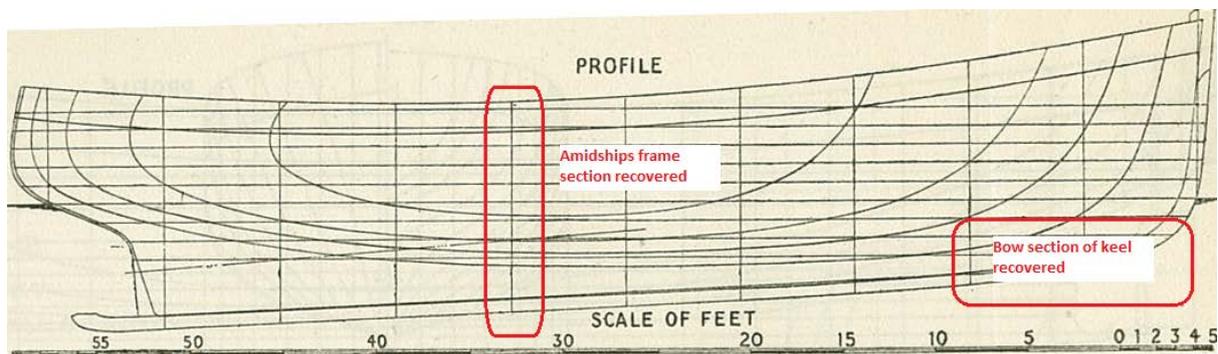
The recovery operation was a success and MAST was able to recover a number of timbers. These included a complete section of portside amidships frames from keel to deck and the bow section of the keel.

The section of the amidships frames consists of five individual timbers connected together and measures over 4 metres in length.

The section of the keel consists of a number of partial timbers including the keel, keelson, breast hook and outer hull planking (cut during recovery) and measures over 1.5 metres in length.

**Image 3: location of recovered sections (after Holt 1946)**

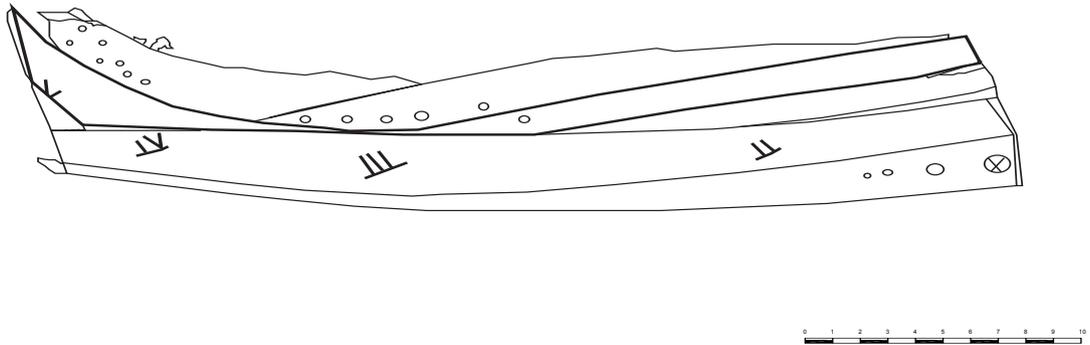
**Image 4** shows where the keel meets the stempost forming the rigid structure capable of taking the bulk of the forces of the waves. The condition of the timber and the structural bolts was solid and required a lot of force during demolition. This along with the survival of surface etchings (the Roman numerals underlined in drawing) marking water lines shows how little damage occurred to the *Sanu* where it lay.

Another aspect of the good timber condition is the high quality of materials used and the quality of construction.

**Image 4: 1:10 (1cm=10cm) digitised scaled drawing of side view of bow section of keel**

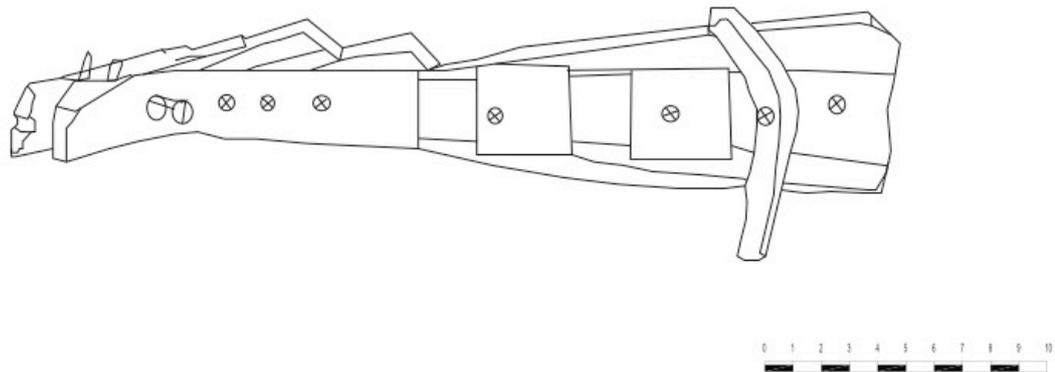
**Image 5** shows the plan view of the keelson timber with the boxed notches cut out. These notches are where the frames are attached to the keelson and keel below and show why the structure was so strong. By notching the timbers, when joined they form a single rigid structure. Another aspect of this section provides a fine example of carvel construction and shows the different construction techniques used to fasten the planking and other thicker framing timbers. The planking is attached by iron nails every few inches along each side of the plank whereas the frames are attached by multiple large iron bolts at joints.

**Image 5: 1:10 (1cm=10cm) digitised scaled drawing of plan view of bow section of keel**

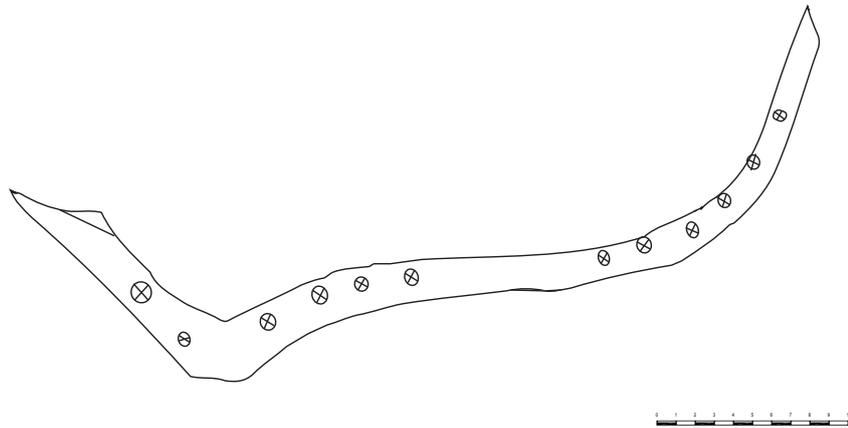
**Image 6** below shows the port side amidships frame section with the first frame on the starboard side also. The bolts where one frame is joined to another can be clearly seen by the crossed circles. This is where the vessel draws its structural strength and is why the vessel remained in good condition for so long. The joint between portside and starboard side first futtocks seen at the bottom left of this image is what would be placed in the notches seen in **Image 5** but at the amidships section of the keelson.

**Image 6: 1:20 (1cm=20cm) digitised scaled drawing of side view of amidships frame section**

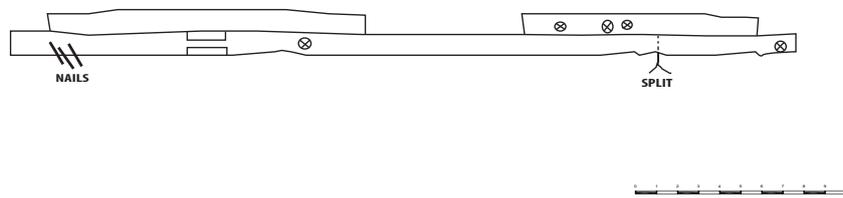
**Image 7** below of the plan view of the frame section shows how the section is made up of five separate timbers. The port side shows the first and second futtock which is joined by the bracing timber heavily bolted between the two. This technique provided a stronger joint than scarfing which was used prior to the invention of the bolt. It was also a quicker technique, therefore of vital importance during wartime with the urgent requirement for shipping.

**Image 7: 1:20 (1cm=20cm) digitised scaled drawing of plan view of amidships frame section**

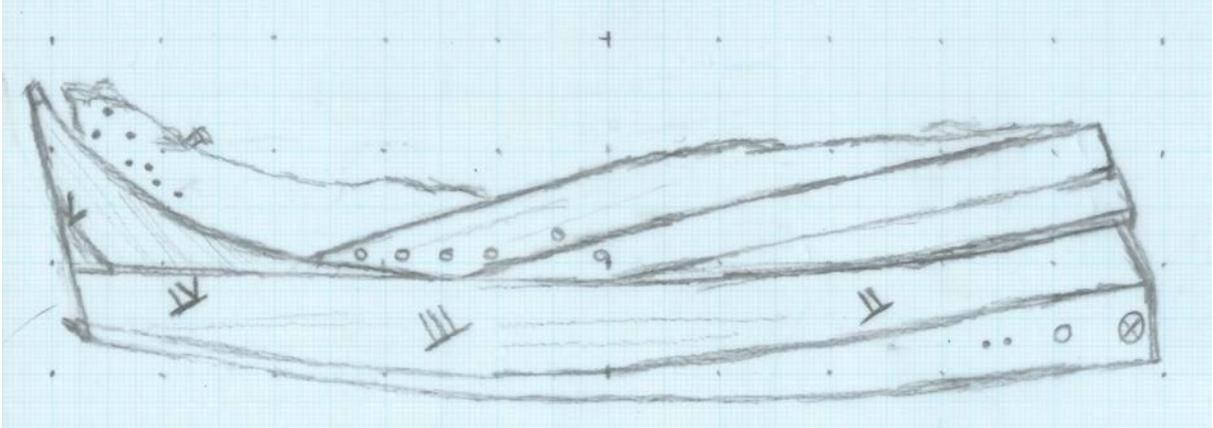
*Image 4: 1:10 scaled drawing of side view of bow section of keel*

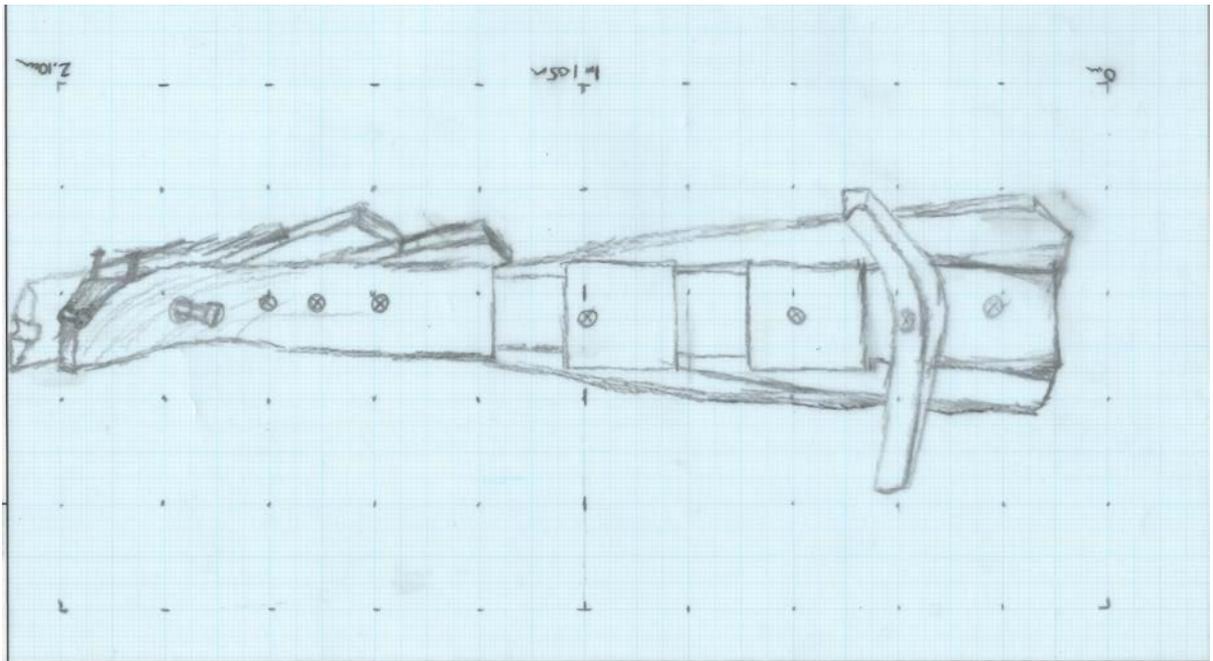
*Image 5: 1:10 scaled drawing of plan view of bow section of keel*

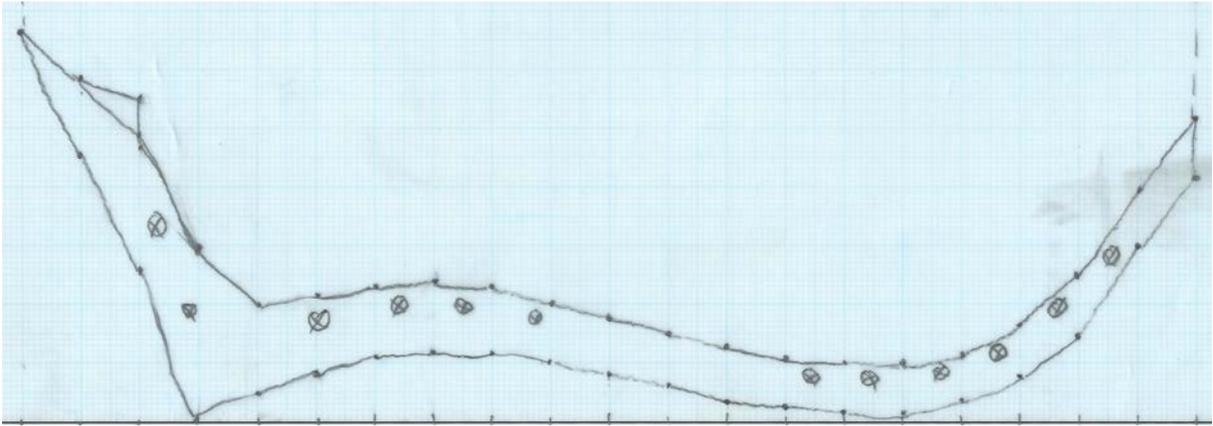
*Image 6: 1:10 scaled drawing of side view of amidships frame section*
